ARCHITECTURAL SURVEY

NEAR WEST HISTORIC DISTRICT ST. CHARLES, ILLINOIS

ST. CHARLES HISTORIC PRESERVATION COMMISSION

ADDRESS 314 Moody Street

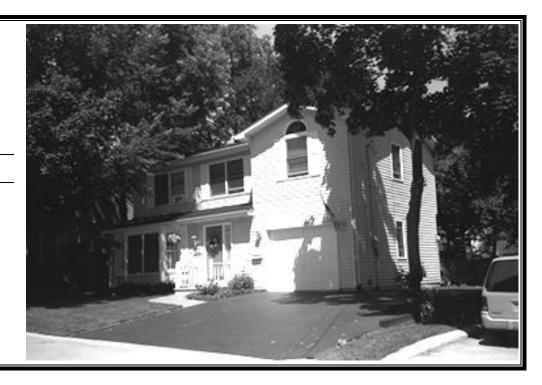
ROLL-IMAGE # <u>102 - 9</u>

- Excellent
- **▶** Good
- Fair
- □ Poor

Architectural Style/Type:	Modern	Exterior Walls (Current):	Aluminum
Architectural Features:		Exterior Walls (Original):	Clapboard
	1000	, ,	
Date of Construction:	1920	Foundation:	Concrete
Source:	Township Assessor Office	Roof Type/Material:	Cross gable/Asphalt shingle
Overall Plan Configuration:	Simple Rectangle w/adds.	Window Material/Type:	Alum/Dbl Hung

ARCHITECTURAL FEATURES: The front gable includes a single car garage and an arched-top window on the 2nd floor. A narrow roof overhang covers the asymmetrical entry and a square bay window. The roof pitch is very shallow (3:12).

ALTERATIONS: The entire house has been remodeled assuming that the date of construction on record is correct. None of the original design elements appear to have been saved. A new porch railing is supported by turned balusters.
